Water Quality Report

Town of Stillwater Portion of the Saratoga Lake Watershed

Town of Stillwater
Saratoga County
New York

LaBella Project No.: CZ32000.12 & CZ32000.13

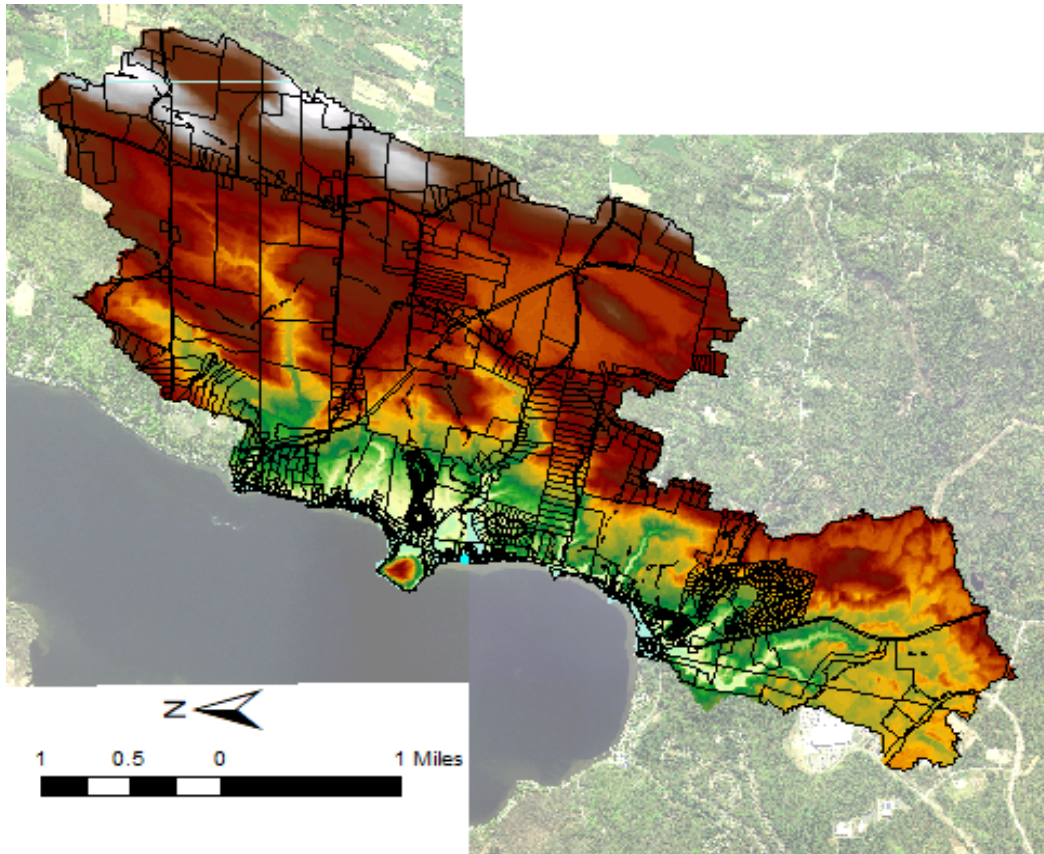
The topography of the Stillwater portion of the watershed was mapped based on publicly available topographic data. In the Stillwater Watershed Topographic Heat Map below, the red areas are areas with higher elevations within the watershed. Stormwater runoff from these areas becomes channeled and forms streams that run into the lake via the green and yellow valleys.

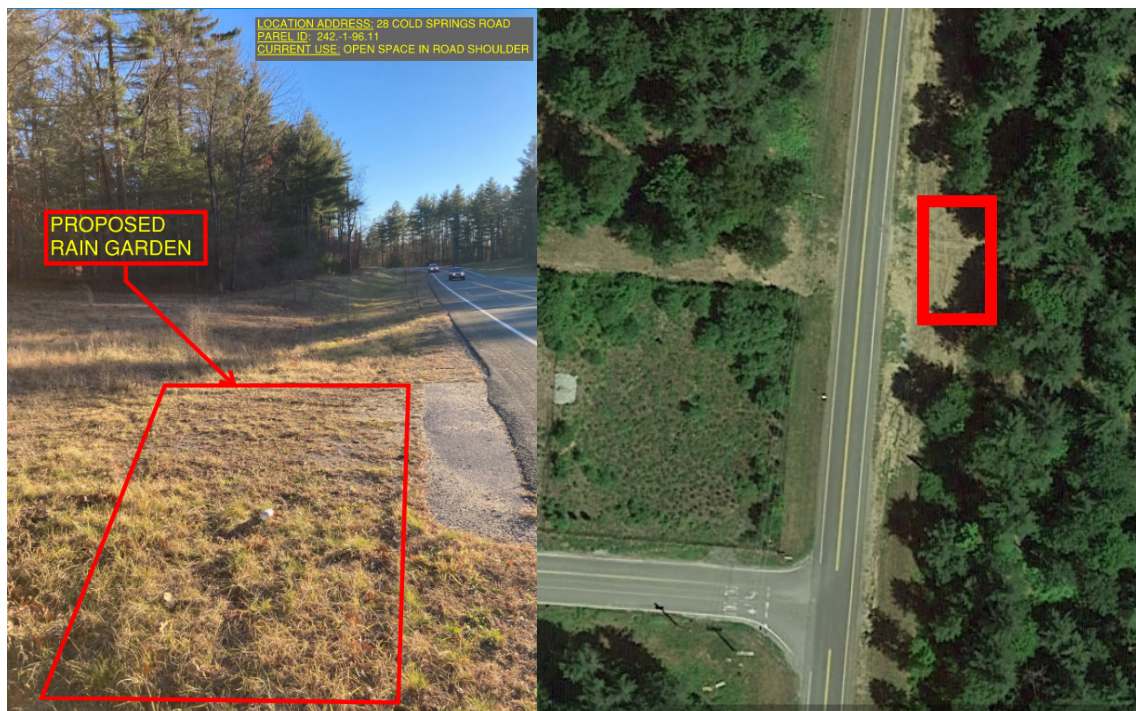
This location is next to Cold Springs Road. The site would collect stormwater runoff from the road, including vehicle pollution and help to treat it prior to entering the surrounded wooded areas and subcatchment. This area should be noted as having increased construction presence in the coming seasons or years and is adjacent to the Global Foundries manufacturing facility. The infiltration tests showed that this area infiltrates very well as the soils consist of mostly sand in the areas and to the depth explored. The rate of infiltration was faster than 1 inch per minute. This property is located within the Luther Forest group's property. The area of the potential green infrastructure sites are shown below.

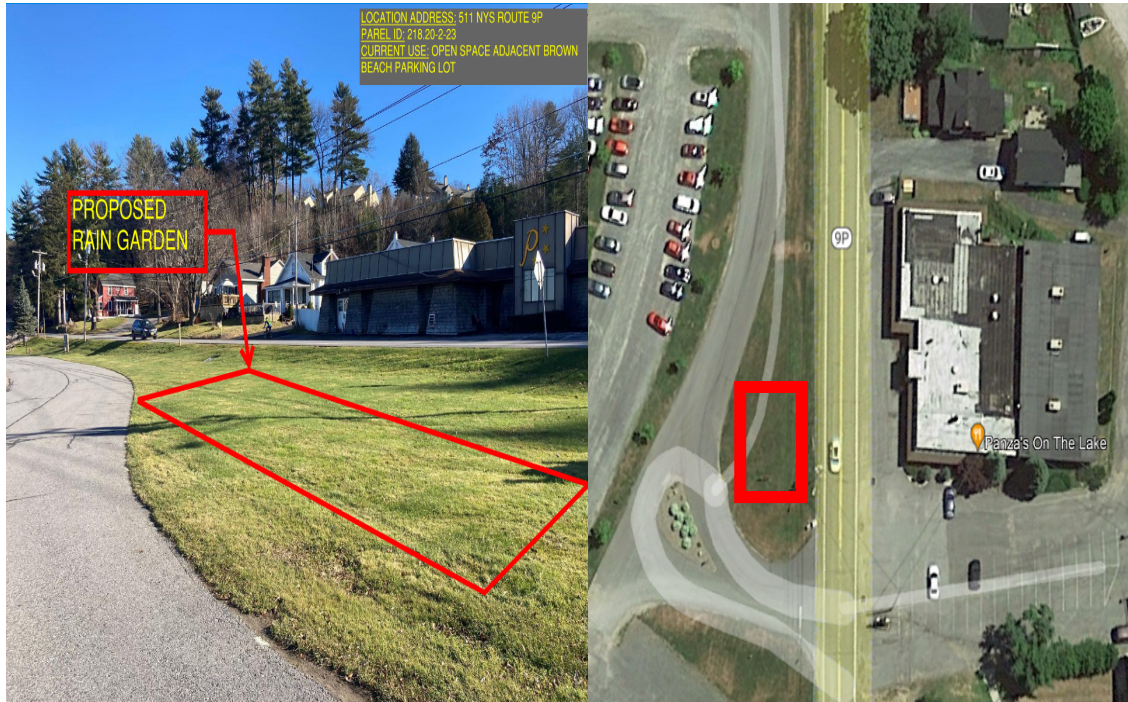
6.4.2 Brown's Beach (a)

This location is located in the open space to the north of Panza's on the Lake. This rain garden would collect stormwater from NYS Route 9P and would be able to collect pollutants before they enter the lake and the Browns Beach public facility. This area has an infiltration rate of approximately 6 minutes per inch. A concern with this option is that this area is sometimes used as overflow parking for large events.

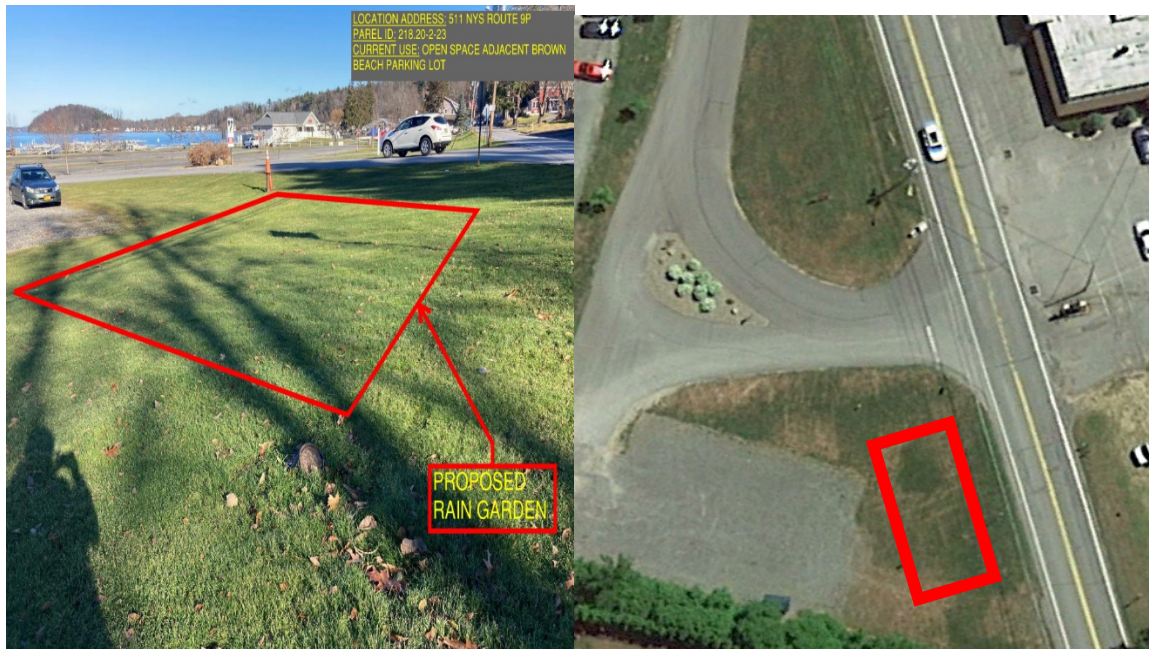
6.4.3 Brown's Beach (b)

This location is a second option for the Browns Beach parcel. This is located immediately to the south of the entrance. The infiltration rate of the soils in this area is approximately 14 minutes per inch. As with the previous area, a concern with this option is that this area is sometimes used as overflow parking for large events.

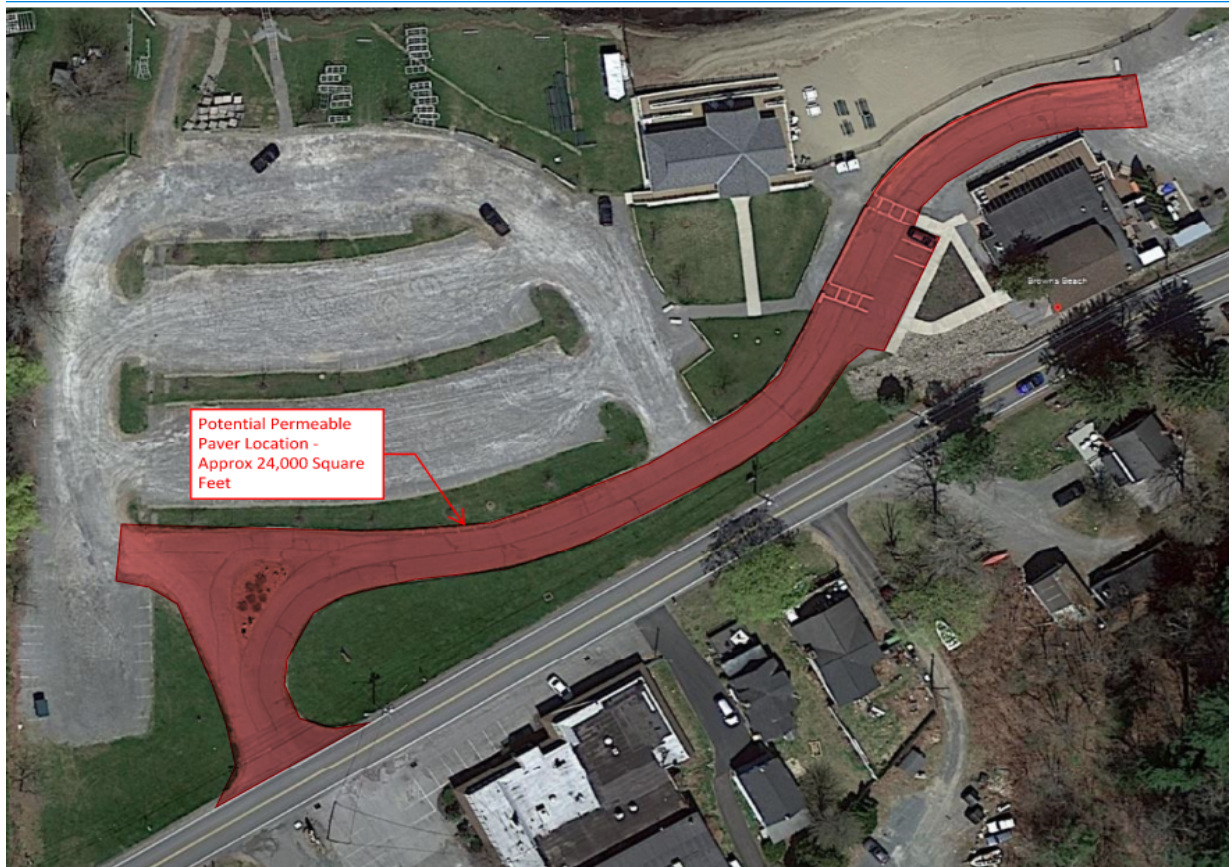
6.4.4 Brown's Beach (c)

The third option at Brown's Beach is to convert the asphalt paved portion of the driveway to permeable pavers. The permeable pavers would encourage stormwater infiltration and reduce the quantity of surface runoff directly entering the lake.

Further, the Brown's Beach (c) option is to construct permeable pavers system to infiltrate water prior to entering the lake.

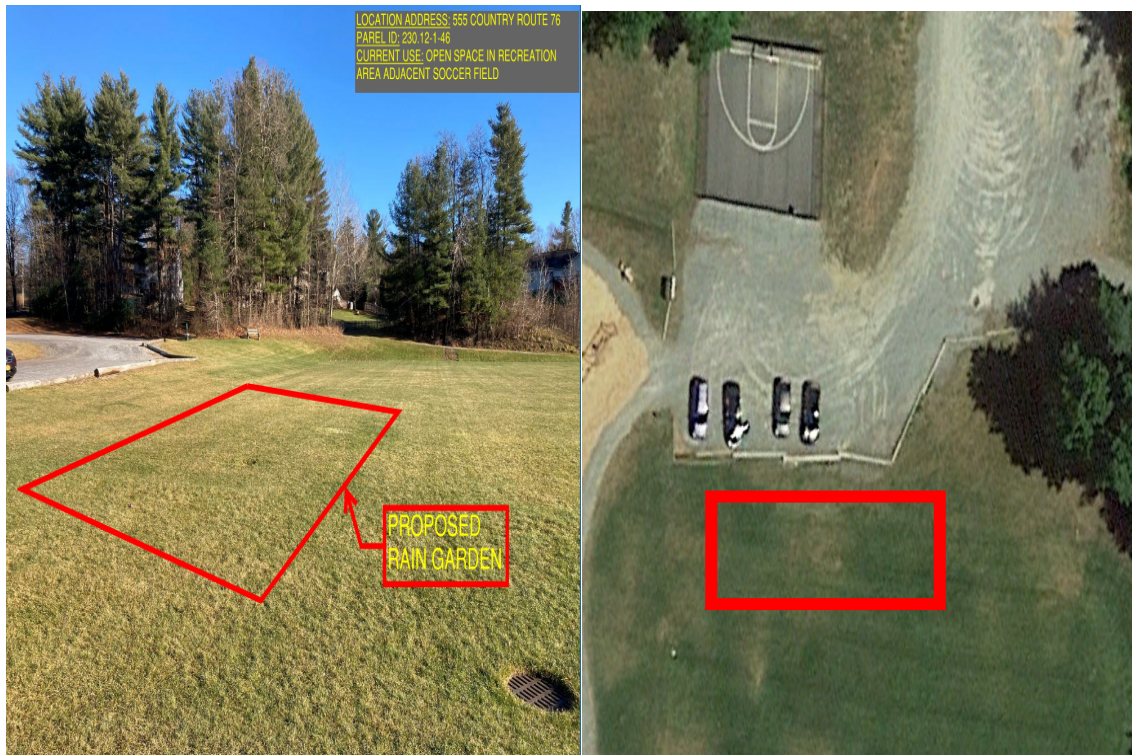
6.4.5 555 County Route 76 (a)

This location is located within Stillwater Glen Hollow Park and is on the north side of the soccer field adjacent to the parking lot. This location would be helpful in absorbing pollutants from the field and would help with the natural beauty of the park. The location has an infiltration rate faster than 1 inch per minute. Though there are no constructability concerns at this location, the proposed rain garden would take up a portion of the playable field.

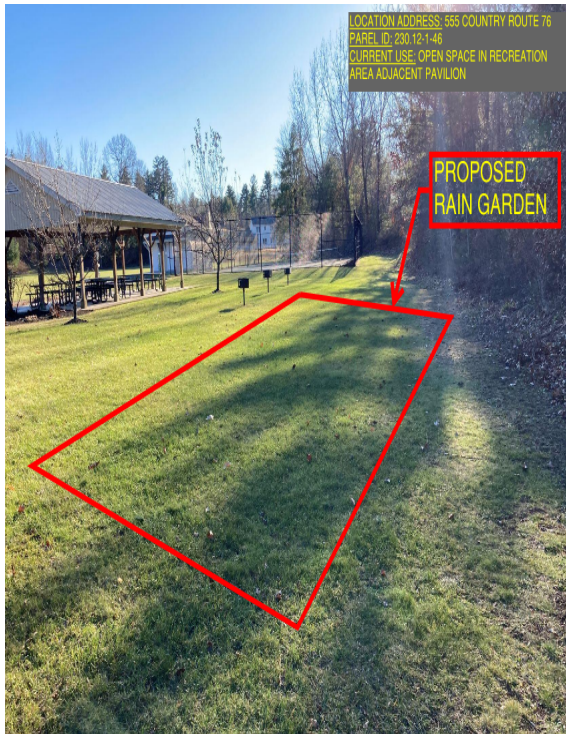
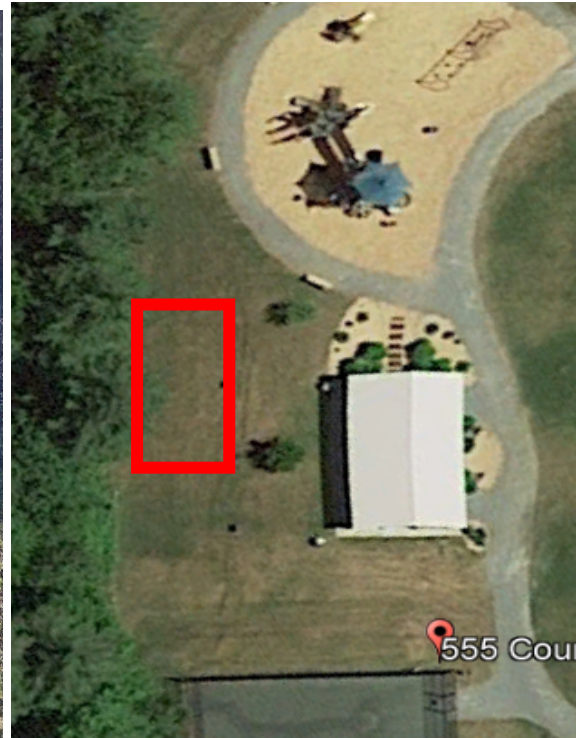
6.4.6 555 County Route 76 (b)

This location is a second option within the Stillwater Glen Hollow Park, located behind the pavilion. The location has an infiltration rate of greater than 1 inch per minute. There are no known issues or concerns with this location.

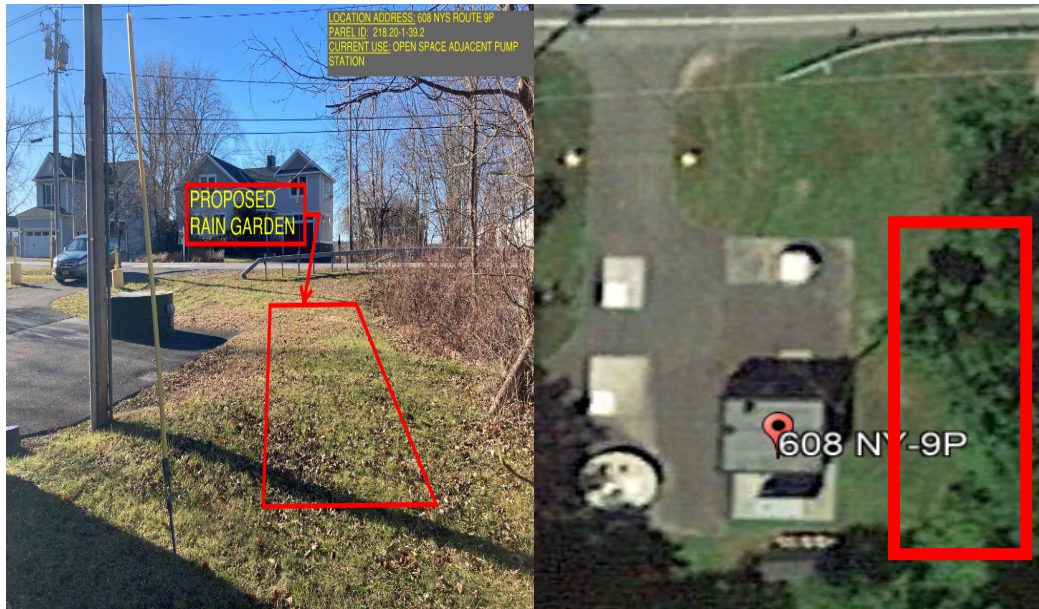
6.4.7 608 NYS Route 9P

This location is along the side of a parking area and municipal utility area. The soils in this area infiltrate at approximately 8 minutes per inch. The location has no major concerns except for the potential utility service needed to be accessed and or maintained.

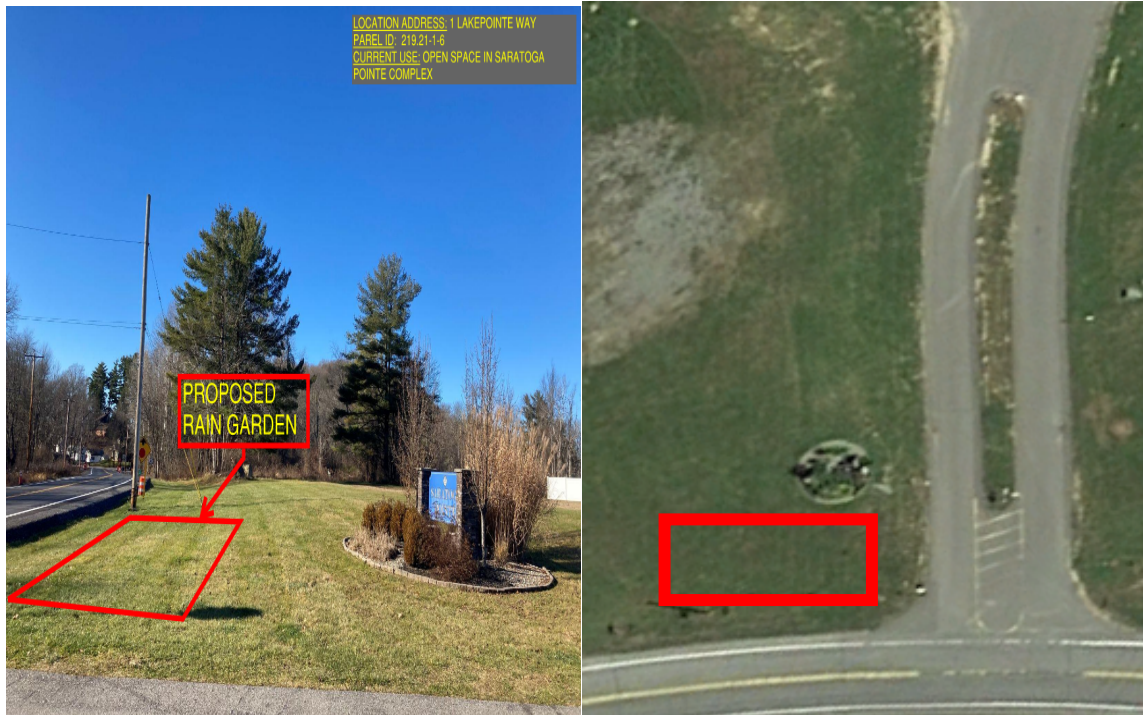
6.4.8 1 Lakepoint Way (a)

This location is adjacent to the entrance of the existing Saratoga Pointe subdivision. This area would be effective at collecting pollutants from the subdivision and taking stormwater runoff from the road. This location has an infiltration rate of approximately 6 minutes per inch. A concern with this site is that the HOA might not approve the construction of a rain garden at this location.

A second location (not pictured) is available just beyond and to the west of the location shown above. This location may be more palatable to the subdivision HOA, as it would be farther removed from the subdivision entrance boulevard.

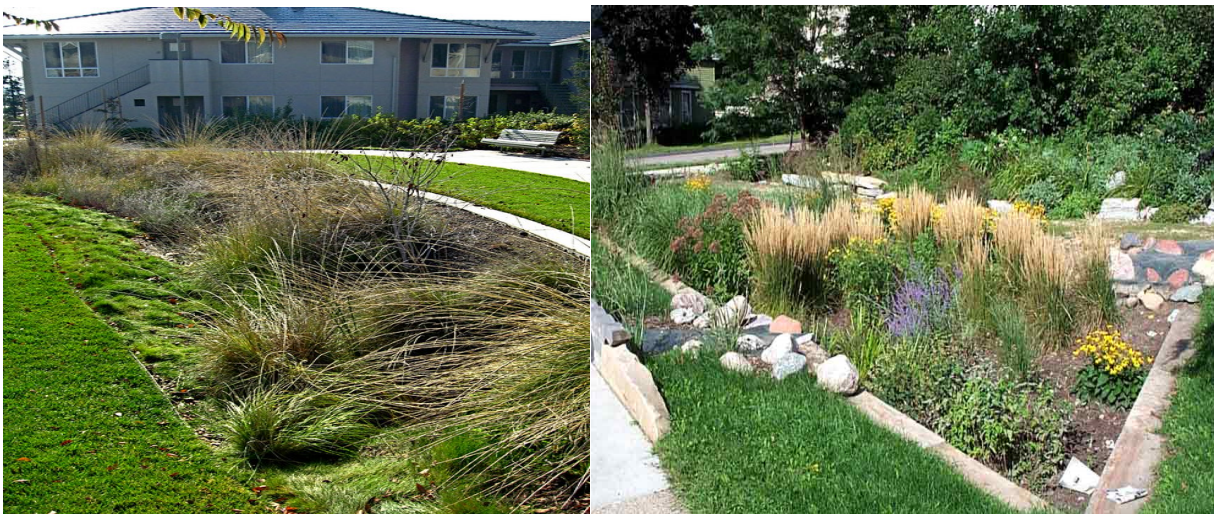
According to the NYSDEC Stormwater Management Design Manual, rain gardens are a passive filter system that allows for the treatment of stormwater runoff. To get the most benefit of the rain garden system, it is important to properly maintain them. As a whole, rain gardens do not require a large amount of maintenance. However, it is important that their makeup remains as intended and that they do not deteriorate and or succumb to invasive species. It is recommended that rain gardens be treated as a component of landscaping and that the parties responsible for maintenance be clearly identified. The most important maintenance items are to weed and mulch the garden and to occasionally replace plants as needed. Using native plants and keeping up with weeding in the first years is critical as the rain garden is not fully established at this time. Lastly, it is important to inspect the rain garden for large gatherings of debris and remove them so that flows throughout the garden as intended. Overall, rain gardens are a low maintenance stormwater treatment system that only requires simple landscaping management to keep operational and functioning as intended.

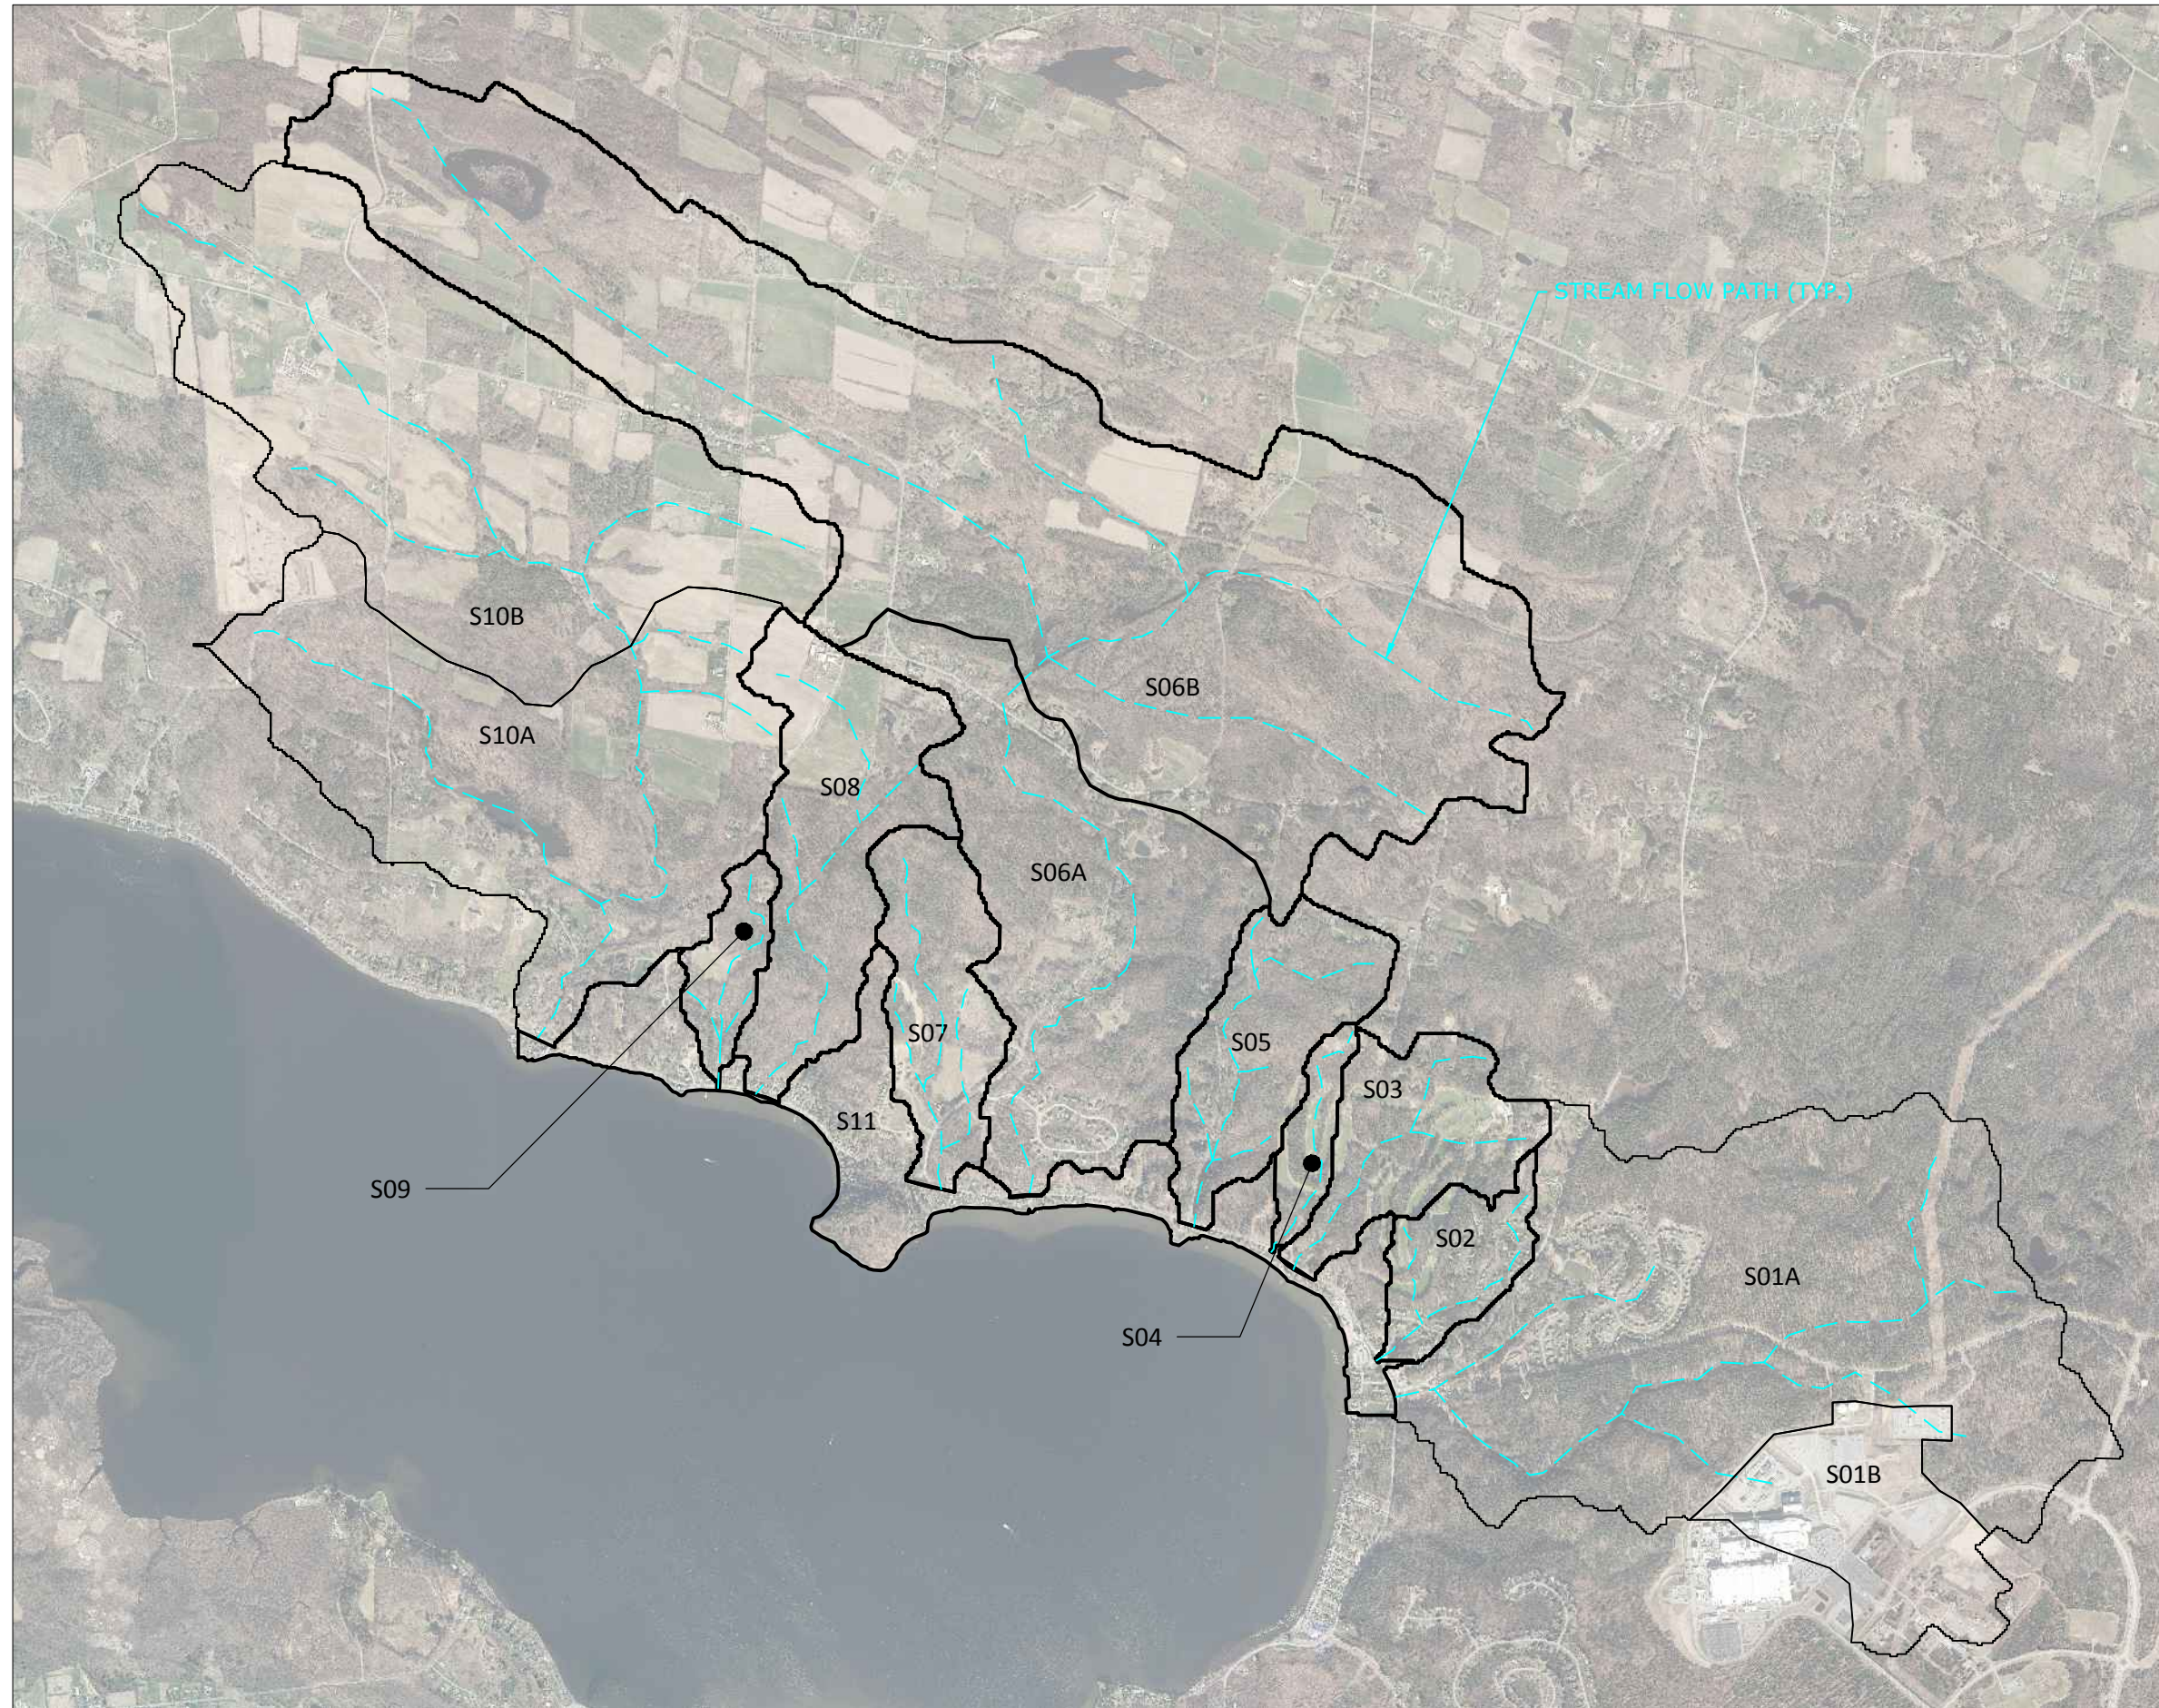
Subcatchment Delineation Map

The watershed within the Town can be broken down into 10 subcatchments, each centered around a well-defined stream channel. These stream channels all flow generally east to west or south to north, and cross under NYS Route 9P via culvert immediately prior to discharging into Saratoga Lake.

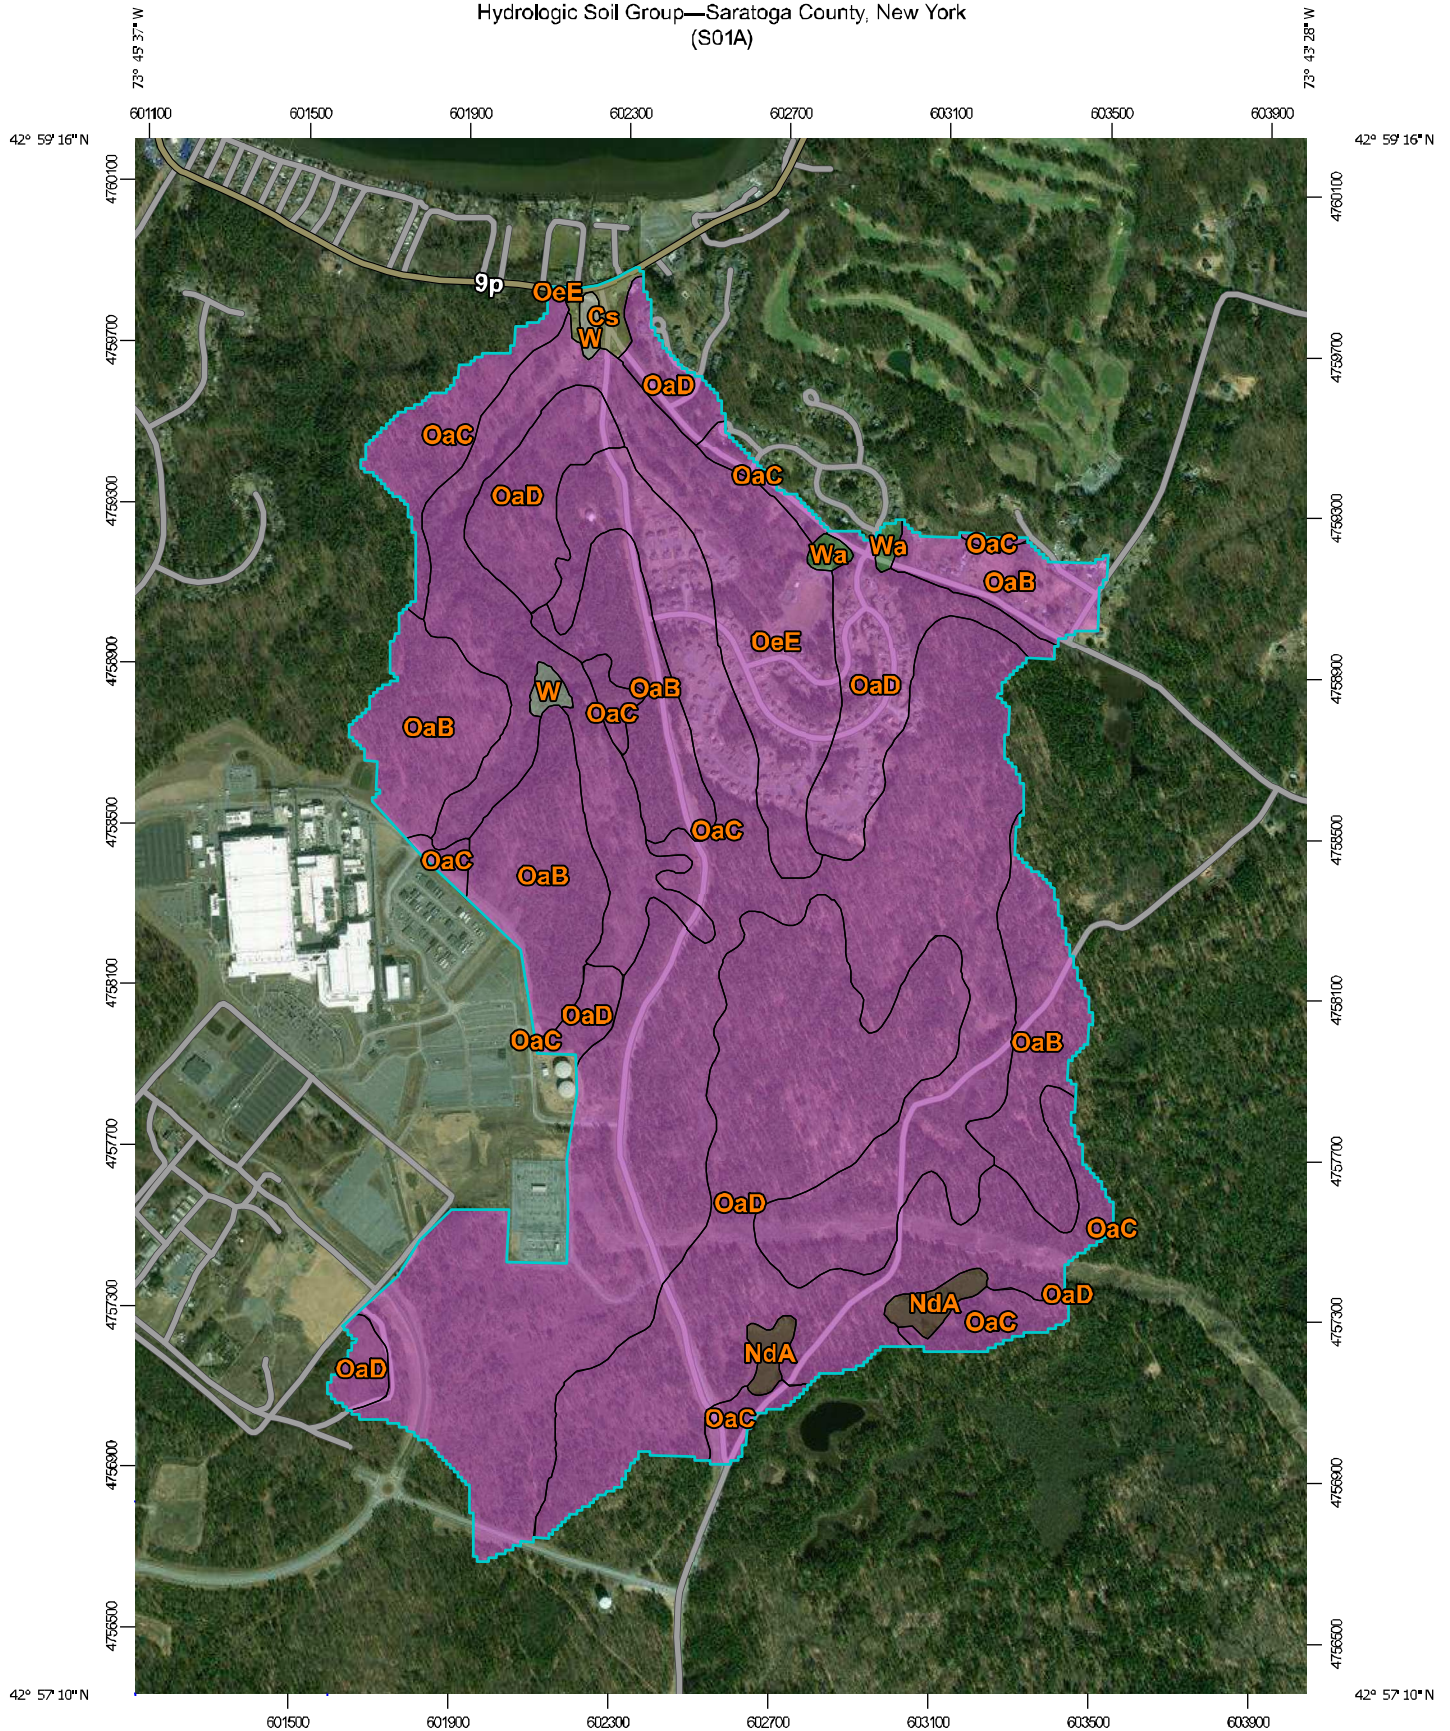
Hydrologic Soil Group—Saratoga County, New York (S01A)

Hydrologic soil groups are based on estimates of runoff potential. Soils are assigned to one of four groups according to the rate of water infiltration when the soils are not protected by vegetation, are thoroughly wet, and receive precipitation from long-duration storms.

Group A. Soils having a high infiltration rate (low runoff potential) when thoroughly wet. These consist mainly of deep, well drained to excessively drained sands or gravelly sands. These soils have a high rate of water transmission.

Group B. Soils having a moderate infiltration rate when thoroughly wet. These consist chiefly of moderately deep or deep, moderately well drained or well drained soils that have moderately fine texture to moderately coarse texture. These soils have a moderate rate of water transmission.

Group C. Soils having a slow infiltration rate when thoroughly wet. These consist chiefly of soils having a layer that impedes the downward movement of water or soils of moderately fine texture or fine texture. These soils have a slow rate of water transmission.

Group D. Soils having a very slow infiltration rate (high runoff potential) when thoroughly wet. These consist chiefly of clays that have a high shrink-swell potential, soils that have a high water table, soils that have a claypan or clay layer at or near the surface, and soils that are shallow over nearly impervious material. These soils have a very slow rate of water transmission.

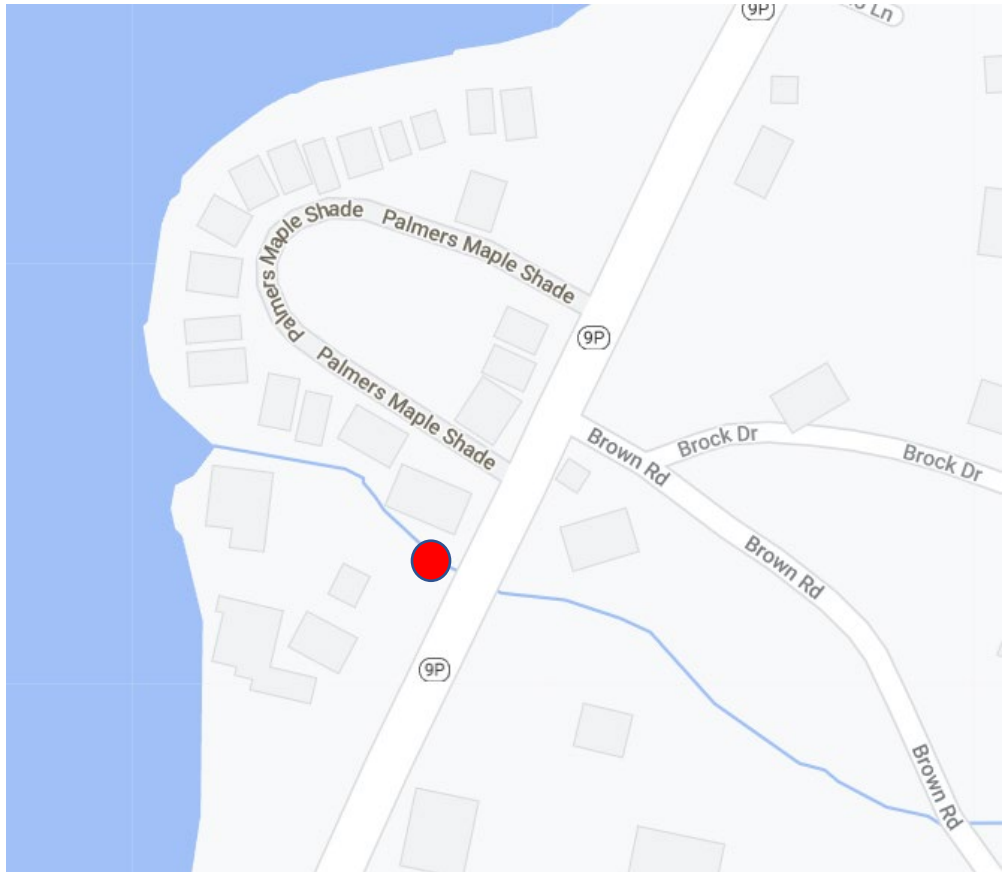
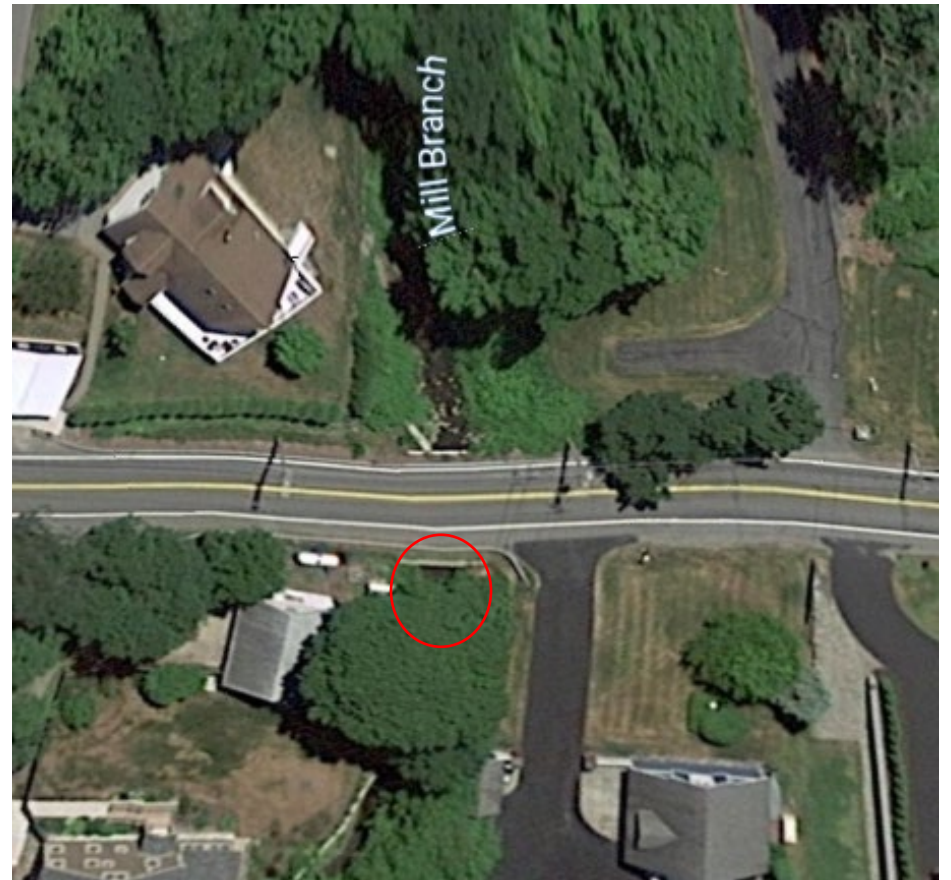
Map 1
Collection Site A

● Sample collected approximately 6 feet downstream from the Route 9P culvert.

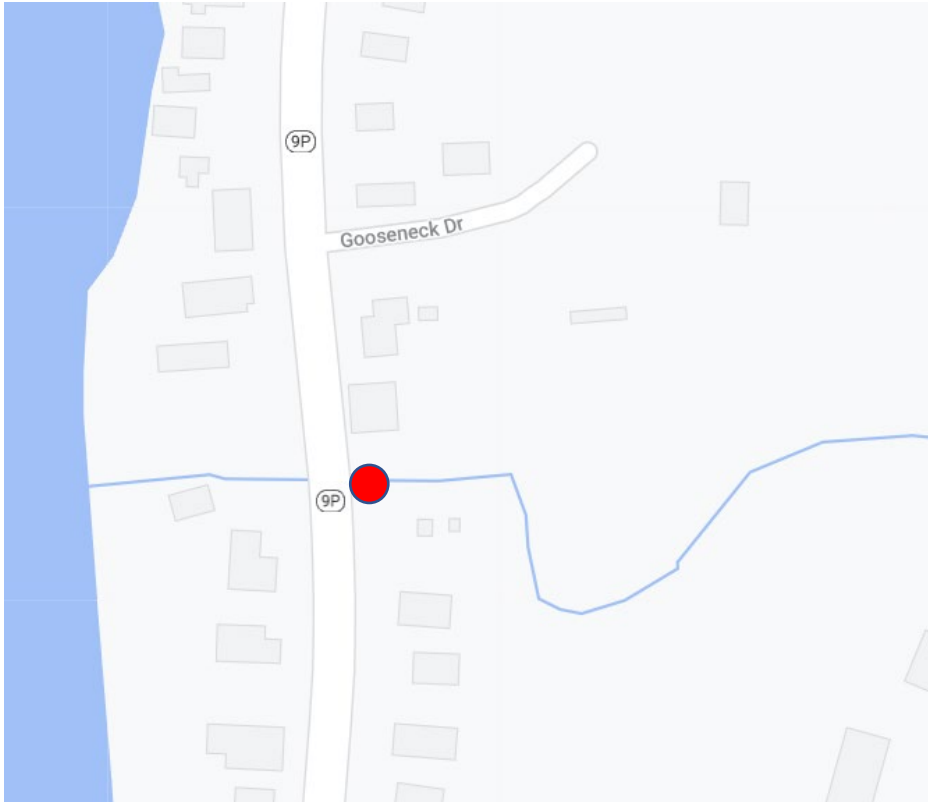
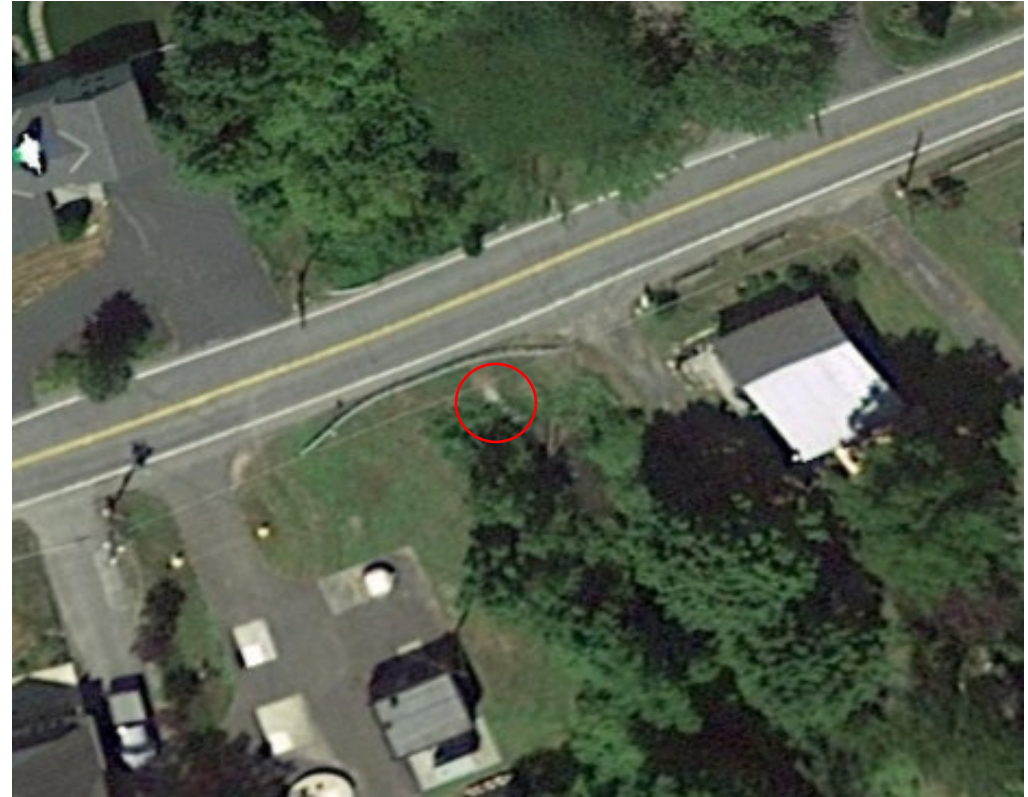
Map 2
Collection Site B

● Sample was collected approximately 8 feet upstream from the culvert.

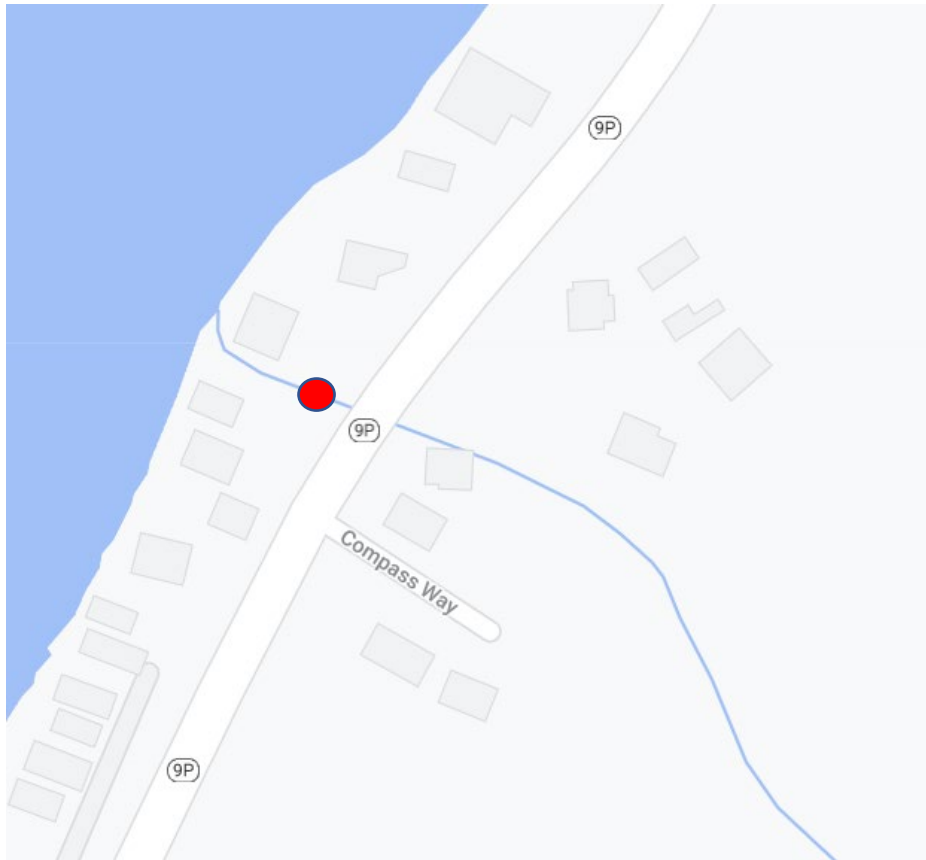
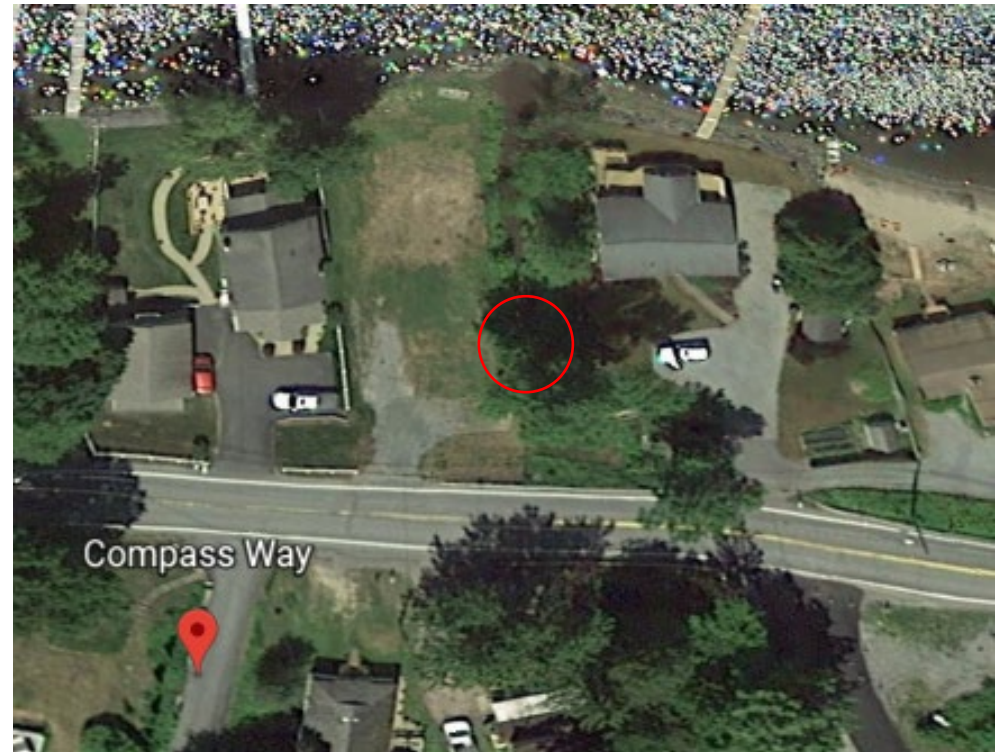
Map 3
Collection Site C

● Sample was collected approximately 25 feet downstream from the Rt 9P culvert.

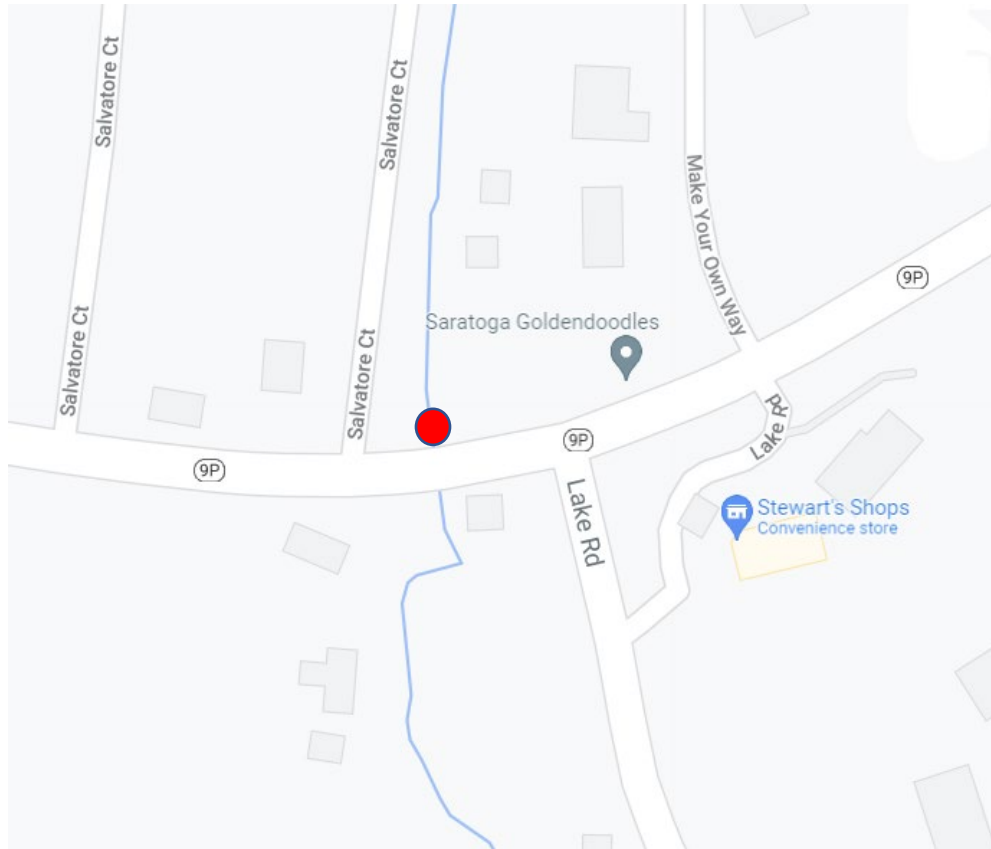
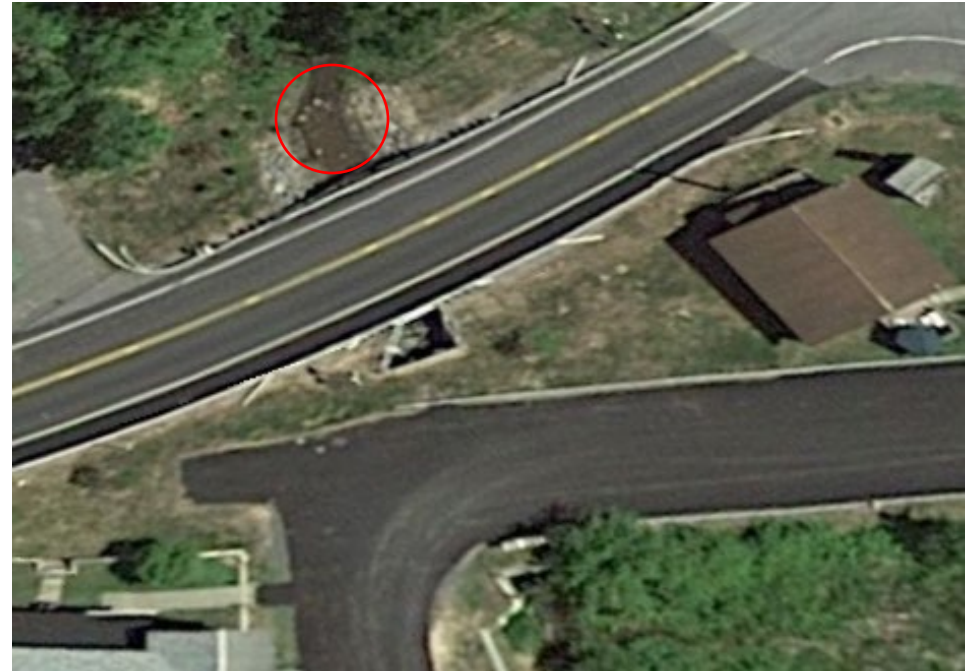
Map 4
Collection Site D

● Sample was collected approximately 10 feet from the Route 9P culvert
