Water Quality Report

Town of Stillwater Portion of the Saratoga Lake Watershed

Town of Stillwater
Saratoga County
New York

LaBella Project No.: CZ32000.12 & CZ32000.13

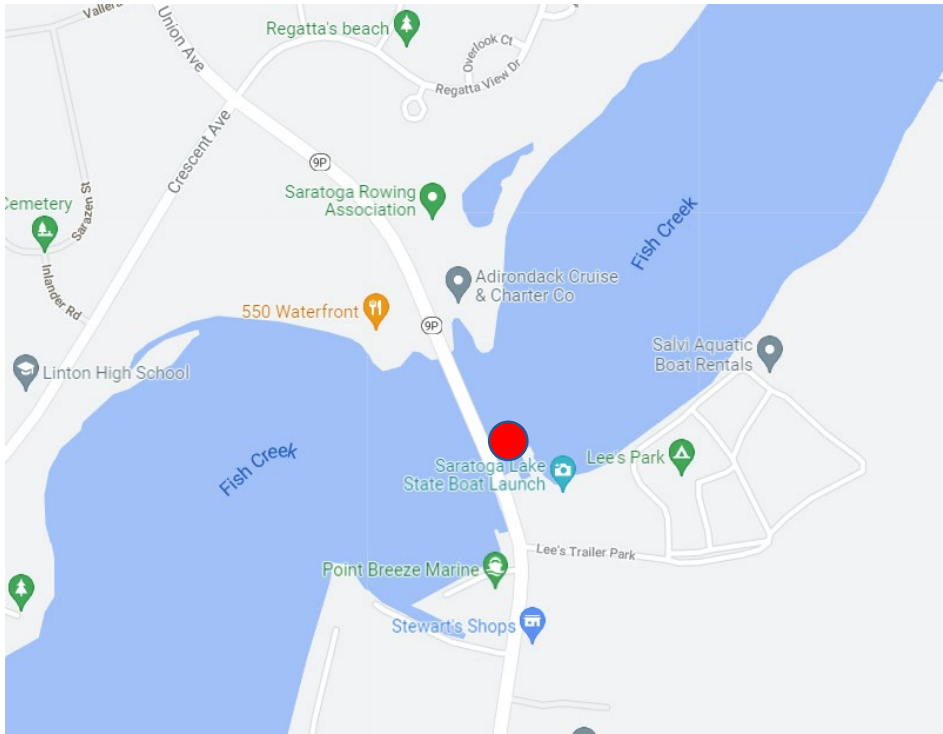
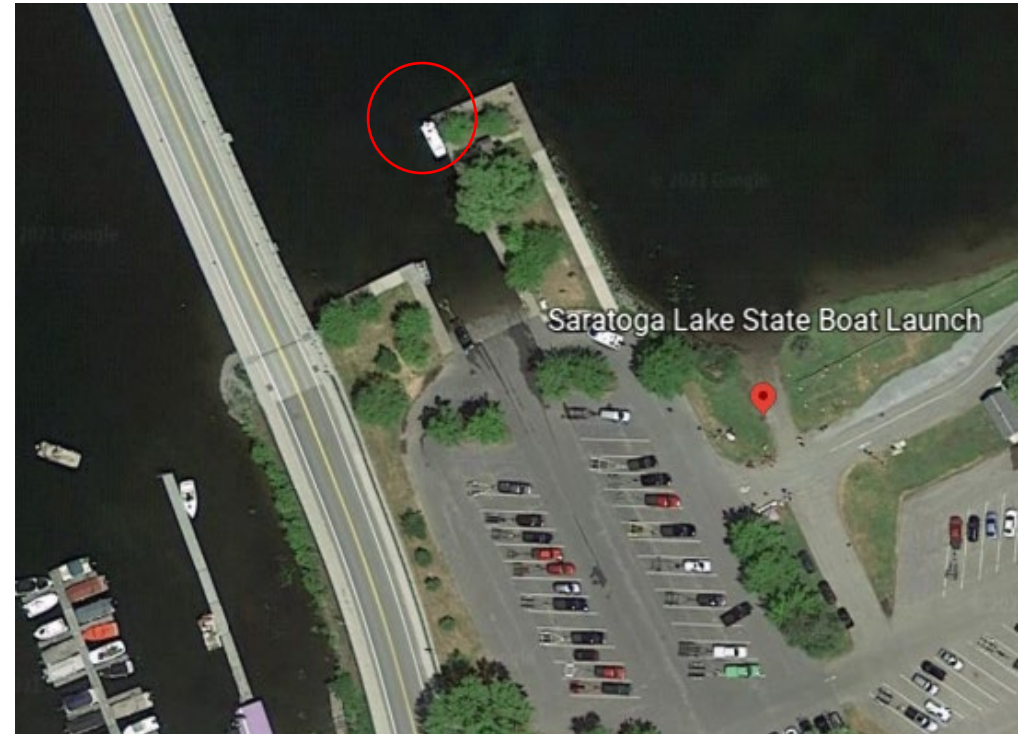
Map 5
Control Sample

● Sample was collected from the south side of the fishing pier, upstream from the boat launch and Route 9P bridge

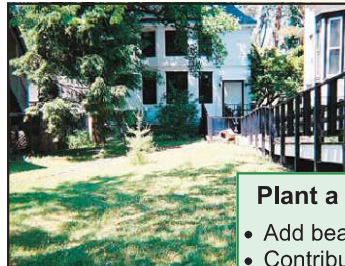
BEFORE:
Rainwater diverted off the roof flows into the yard.

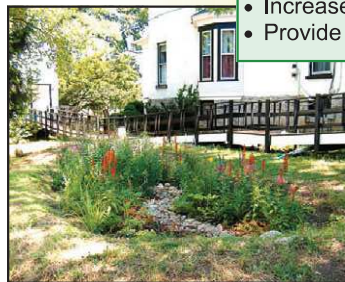
AFTER:
The gutter directs rain from the roof into a beautiful rain garden, which holds the water as it soaks into the ground. This rain garden is located at the Zen Center of Syracuse and helps to prevent stormwater from entering Onondaga Creek & Onondaga Lake.

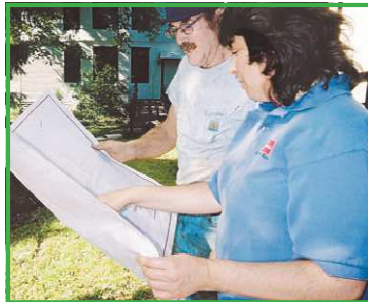
Rain gardens can be designed to catch water from a roof or even a driveway. When choosing a location for your garden, pick an area that is relatively flat or that has a slight slope. Keep the following considerations in mind:

- Rain gardens are **NOT** a solution to wet areas! The garden must have good drainage so that water can soak in within 24 hours after a rainfall. This will also prevent your garden from becoming a mosquito haven!
- The garden should be at least 10 feet away from the house.
- The garden should receive full or partial sunlight.
- Avoid the area over a septic system.
- The garden must include an overflow outlet that will transport excess rainfall to a proper location (not your neighbors lawn!).

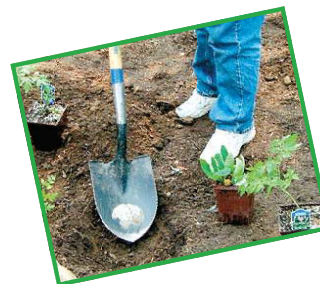
- Use string to outline the shape of your garden.
- On a slope, more digging will be required on the uphill side. Use extra soil to build a berm on the downhill side.
- The bottom of the garden must be flat & level.
- Don't forget to make an overflow for heavy rain events!

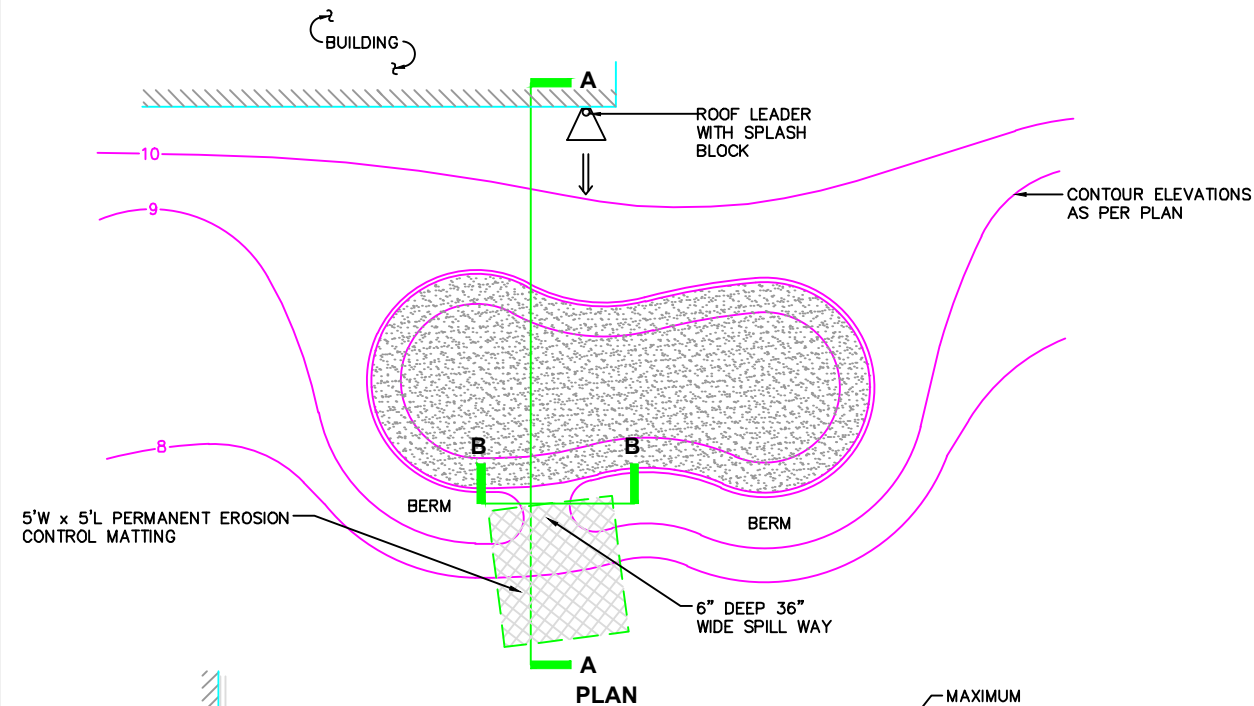
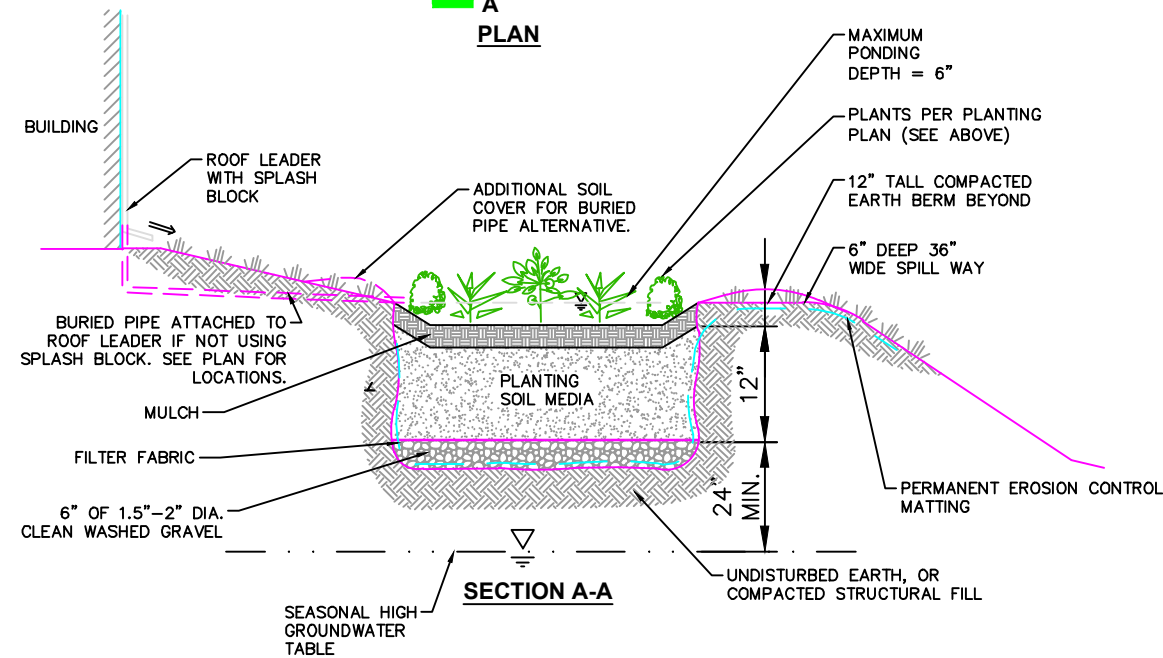
TYPICAL RAIN GARDEN AND PERMEABLE PAVER DETAILS

TYPICAL RAIN GARDEN DETAIL
SCALE: NTS
LAST REVISED: SEPT 2022
